REMEDIAL ACTION PLAN

Former Leatherworks Site
Girard, Trumbull County, Ohio

October 6, 2021

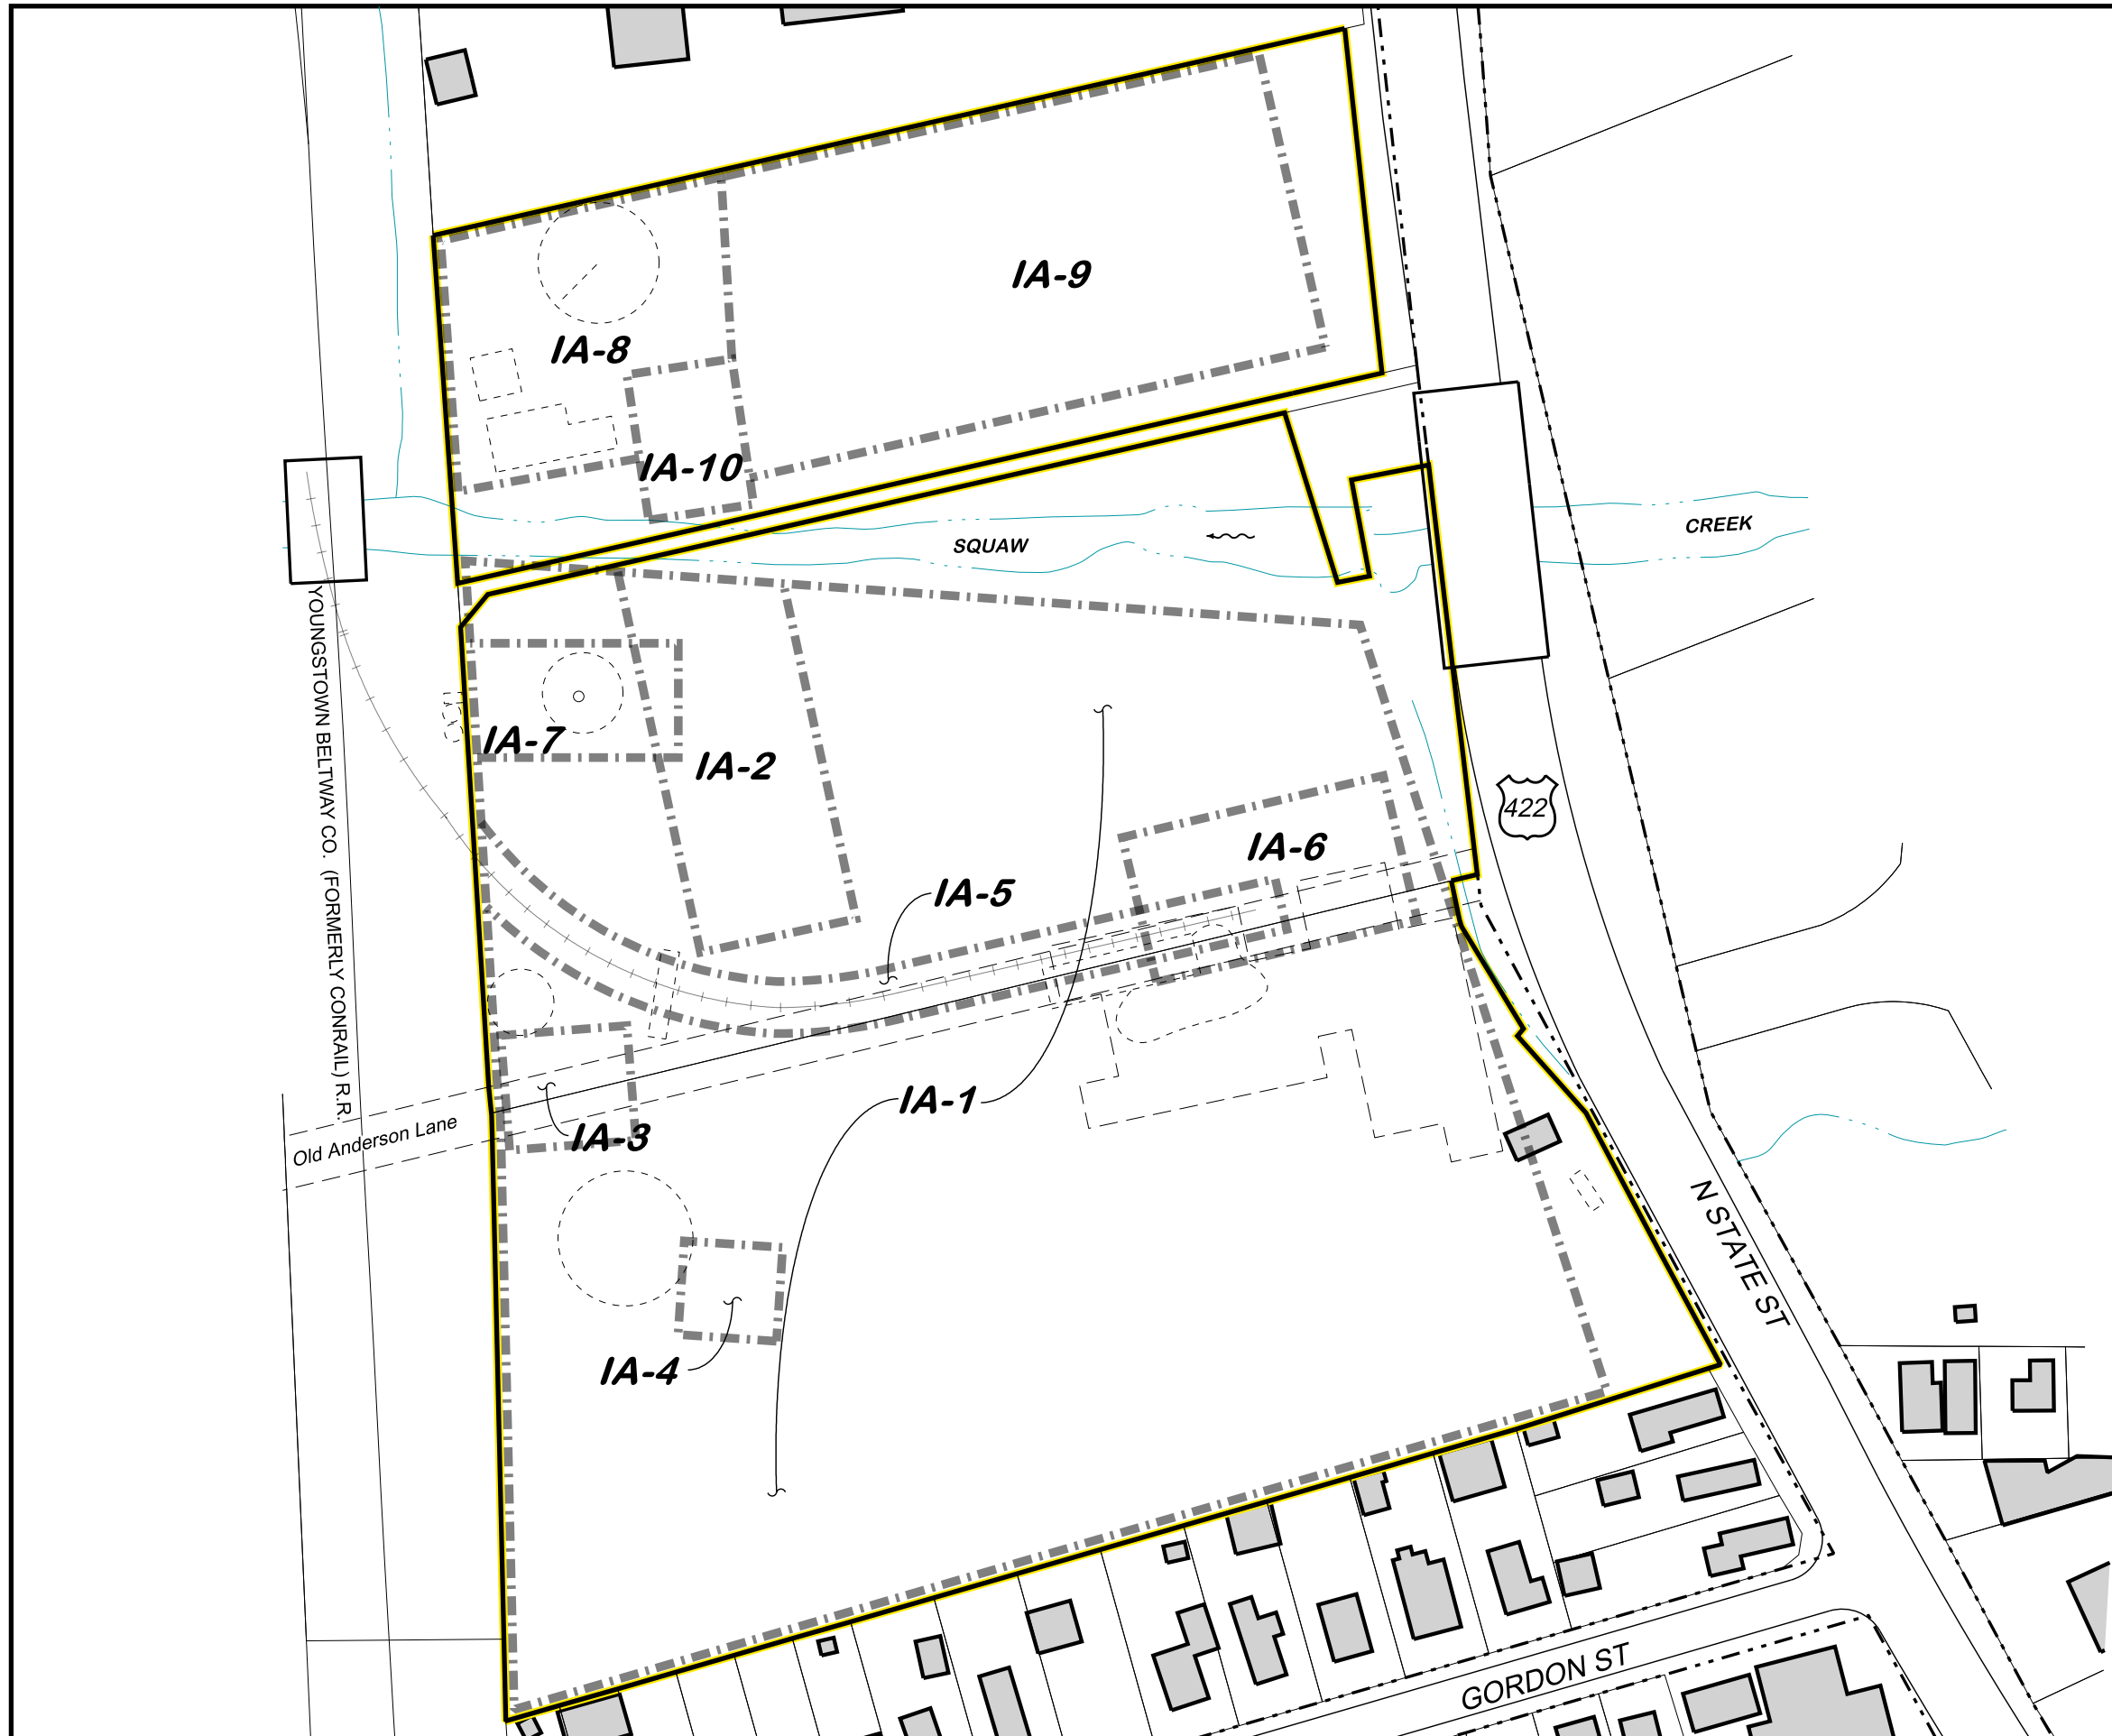
Identified Area Location Map

- IA-1: Historical Use for Leather Tanning Operations and Metals Storage/Disposal
- IA-2: Titanium Shavings/Drum Accumulation Area #1 (79 drums west of bldg. 8 & 9)
- IA-3: Drum Accumulation Area #2 (30 drums between reservoirs)
- IA-4: Drum Accumulation Area #3 (30 drum south of bldg. 25)
- IA-5: Rail Spur
- IA-6: Former Transformer House and Engine Room
- IA-7: Oil/Gas Well
- IA-8: Historical Use for Waste Water Treatment Plant
- IA-9: Three Waste Water Treatment Lagoons
- IA-10: Disposal of Coal-related Waste

Identified Areas are interpreted from Figures 4A, 4B and 4C of a Phase I ESA by Turn-Key Environmental, Inc. dated September 23, 2013 and a Phase I ESA by McCabe Engineering dated October 2003. Locations are very approximate.

Soil sample analyses from the IAs demonstrated that VAP direct-contact standards for commercial/industrial (C/I) land use were exceeded at several areas of the Property. IAs and soil sampling locations are shown on the attached *Identified Area Location Map* and *Sampling Location Map*, respectively. The chemicals of concern (COCs) that were found to exceed applicable C/I direct-contact standards include antimony, arsenic, lead, mercury, PCBs, and total petroleum hydrocarbons (TPH). The most prevalent of these COCs was lead, with the other COCs being identified above applicable standards in relatively small and isolated areas. Soil direct contact standards for lead exceed VAP
